Deben Estuary Entrance Review

Defence sensitivity

Client: Suffolk Coastal District Council

Date: 31 October 2016

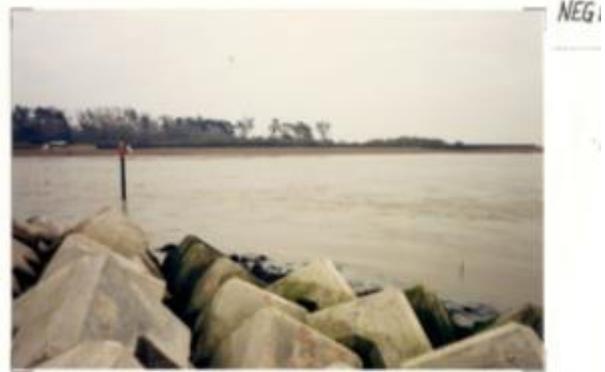
LOCATION SAILING CLUB FRONTAGE DATE NOV 88
 COMMENTS TRIPOD TERMINAL GROUVE NOTE: EROSION

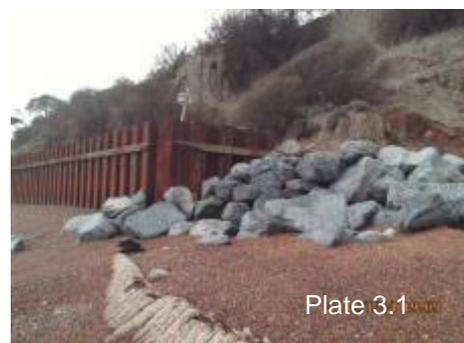
Plate 3.1

In the case of the Bawdsey Manor wall, there is concern over a reduction of beach level resulting in instability, although it has been assessed that this stability issue is not at present critical. However the wall suffers from substantial overtopping and there are areas where holes developing in the sheet piles have resulted in local wash out. Local damage has occurred at the northern end of the wall and this has been supported by rip rap armour (Plate 3.1).

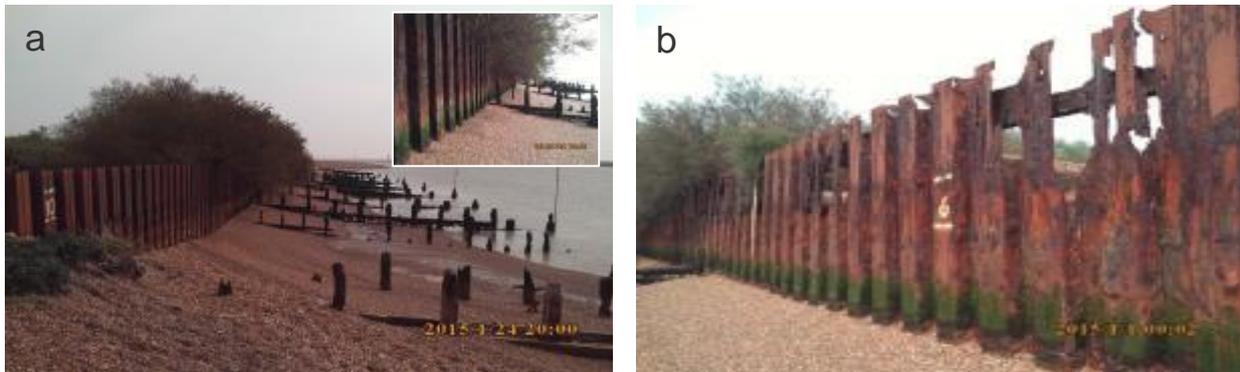
Plate 3.2. Bawdsey Quay Steel Sheet Pile Wall - a) Northern section, b) Central section

Over the northern section of the wall beach levels remain slightly higher and the wall appears to have suffered less deterioration (Plate 3.2a). This section of wall is supported by tie (struts) connected to a waling beam just below the crest of the piles. These piles do retain sediment behind and based on previous reports has a toe depth of around -5m OD.

Further south, over the central section of the wall, there has been severe corrosion (Plate 3.2b) and, where this has occurred, there has been significant loss of the shingle behind.

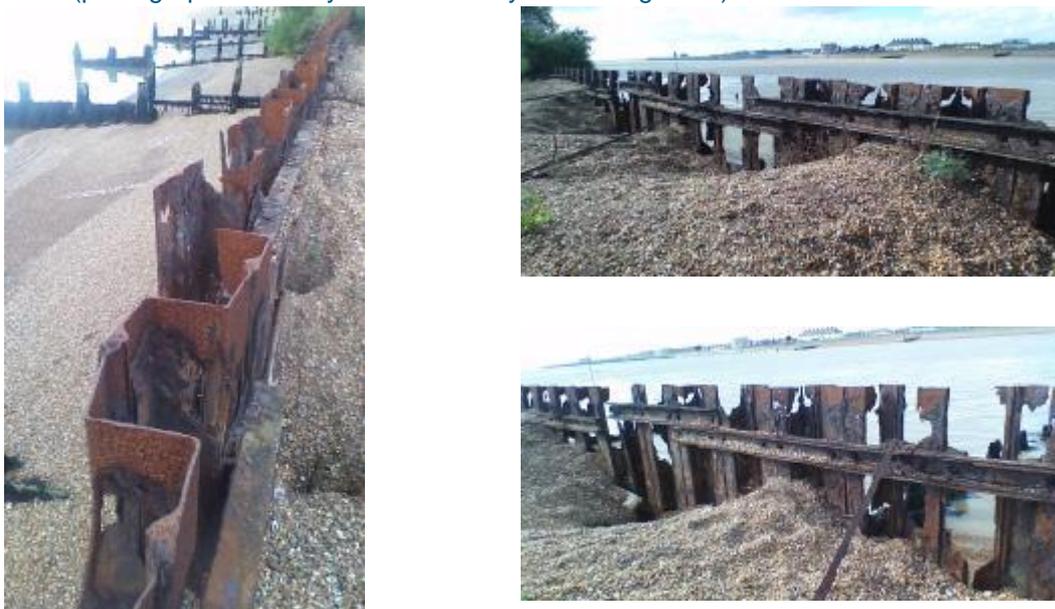
Plate 3.3. Bawdsey Quay Steel Sheet Pile Wall – recent inspection of the central section of wall (October 2016).

This shows both loss of shingle through the main holes that have developed in the wall but also local sink holes developing in other areas. The photographs clearly show the poor condition of both the crest waling and the thinning of the ties. It cannot be ruled out, from the more recent monitoring, that there are not further holes below beach level or indeed, given the variation in construction around the whole area that over this particular section of the wall the actual piles were not driven to a more shallow depth.

Subject to continued monitoring of the development of sink holes and further evidence of loss of sediment behind, below the point of the obvious damaged sections of piling, it is possible that sediment is being lost at the toe of this central section of wall. Clearly further substantial erosion of this beach could threaten the wall.

While in the longer term, the solution to this problem will need to be considered in relation to the wider management of the area, consideration might be given to cutting off the deteriorated section of piles. This would certainly not increase the flood risk to the hinterland as the wall does not at present provide a competent flood defence.

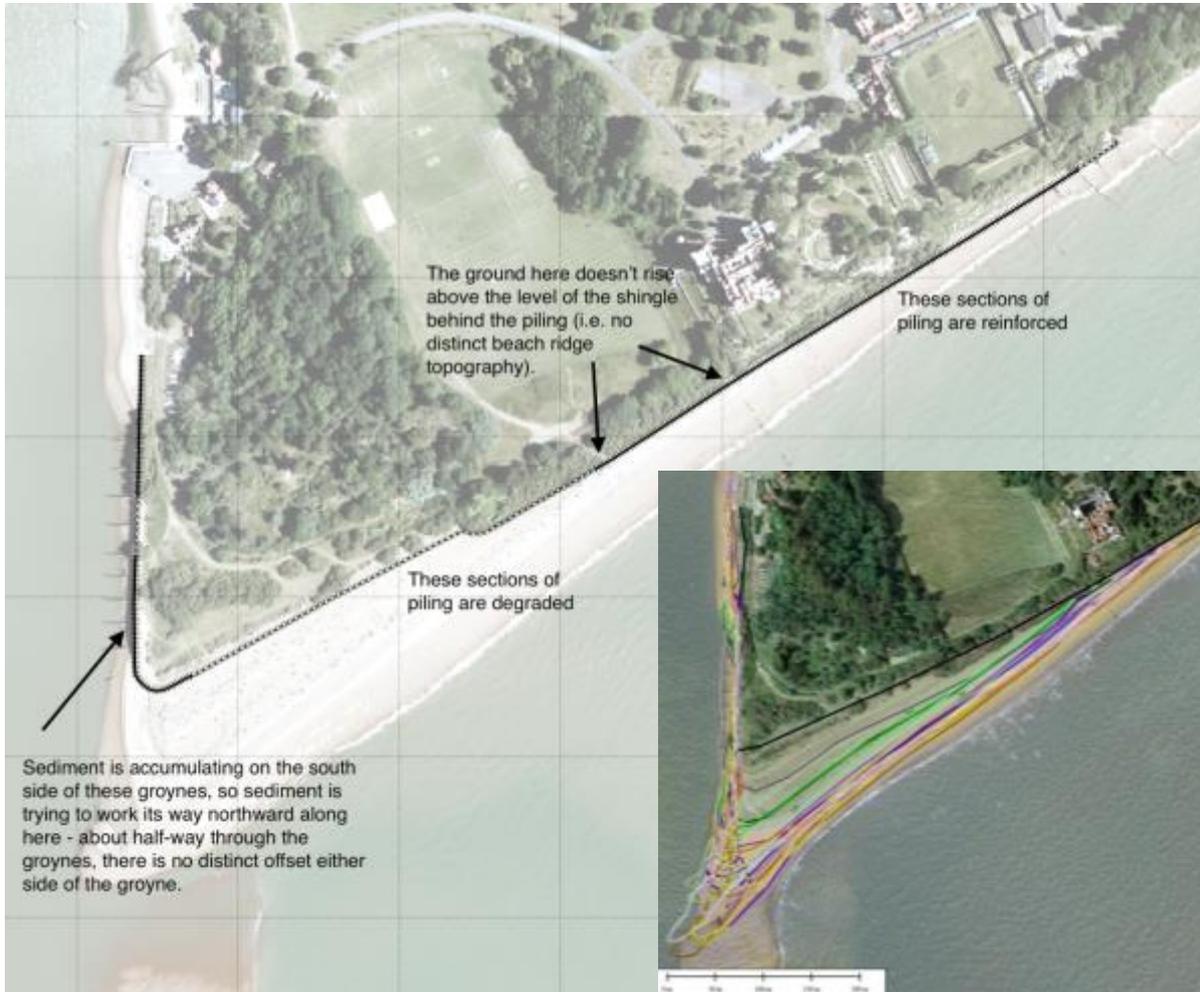
Figure 4.3. Visual assessment of open coast defences (Buringham 2016 (pers com))

A recent inspection of the frontage, to the west of the Manor, highlighted a section of piles (referred to as Section 4 in the previous report) where, where visible, the top of the piles are severely degraded. This tends to be further towards the Point. Closer to the Manor, and directly across the low lying land, the visible section of the piles show some damage but remain well buried. This confirms the previous

assessment, within the 2003 report, recording that the section most severely damaged are Frodingham 2 piles and the shorter section of buried piles are Frodingham 5.
