Deben Estuary Entrance Review

Defence sensitivity

Client: Suffolk Coastal District Council

Date: 31 October 2016

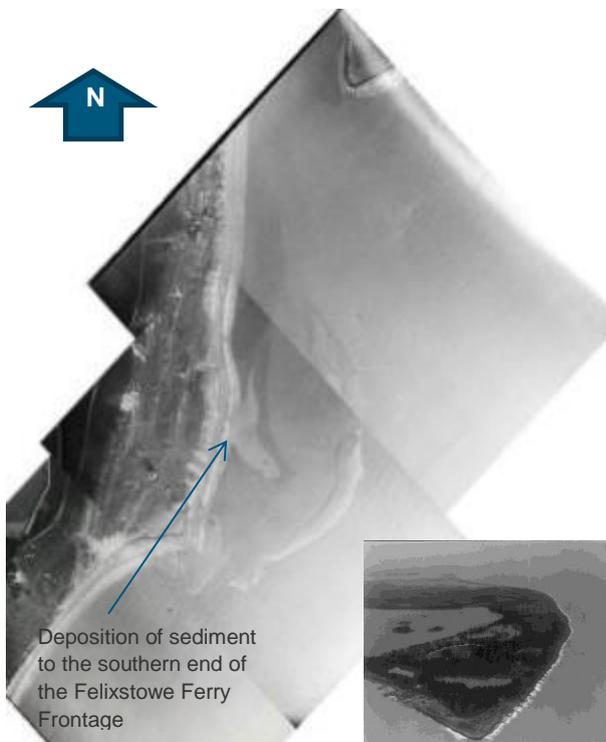
It may be seen that all evidence of the upper northern structure of the Knolls has been flattened and, from the inset of the Bawdsey Manor, that the sheet piled corner at the mouth of the estuary is exposed. There is no distinct channel running south but there is evidently a major deposition of sediment along the southern section of the Felixstowe Ferry frontage. There remains a relatively healthy beach running further to the north on this western side of the estuary.

It is suggested that the normally tidally dominated regime was, during this event, overwhelmed by wave action and wave processes. This is supported by the bathymetric plot for 1961 (Figure 2.4), that the storm consolidated a large volume of sediment within the area of the outer estuary. It is further suggested that it then took over a decade for this sediment to be reworked into the more typical tidally dominated form.

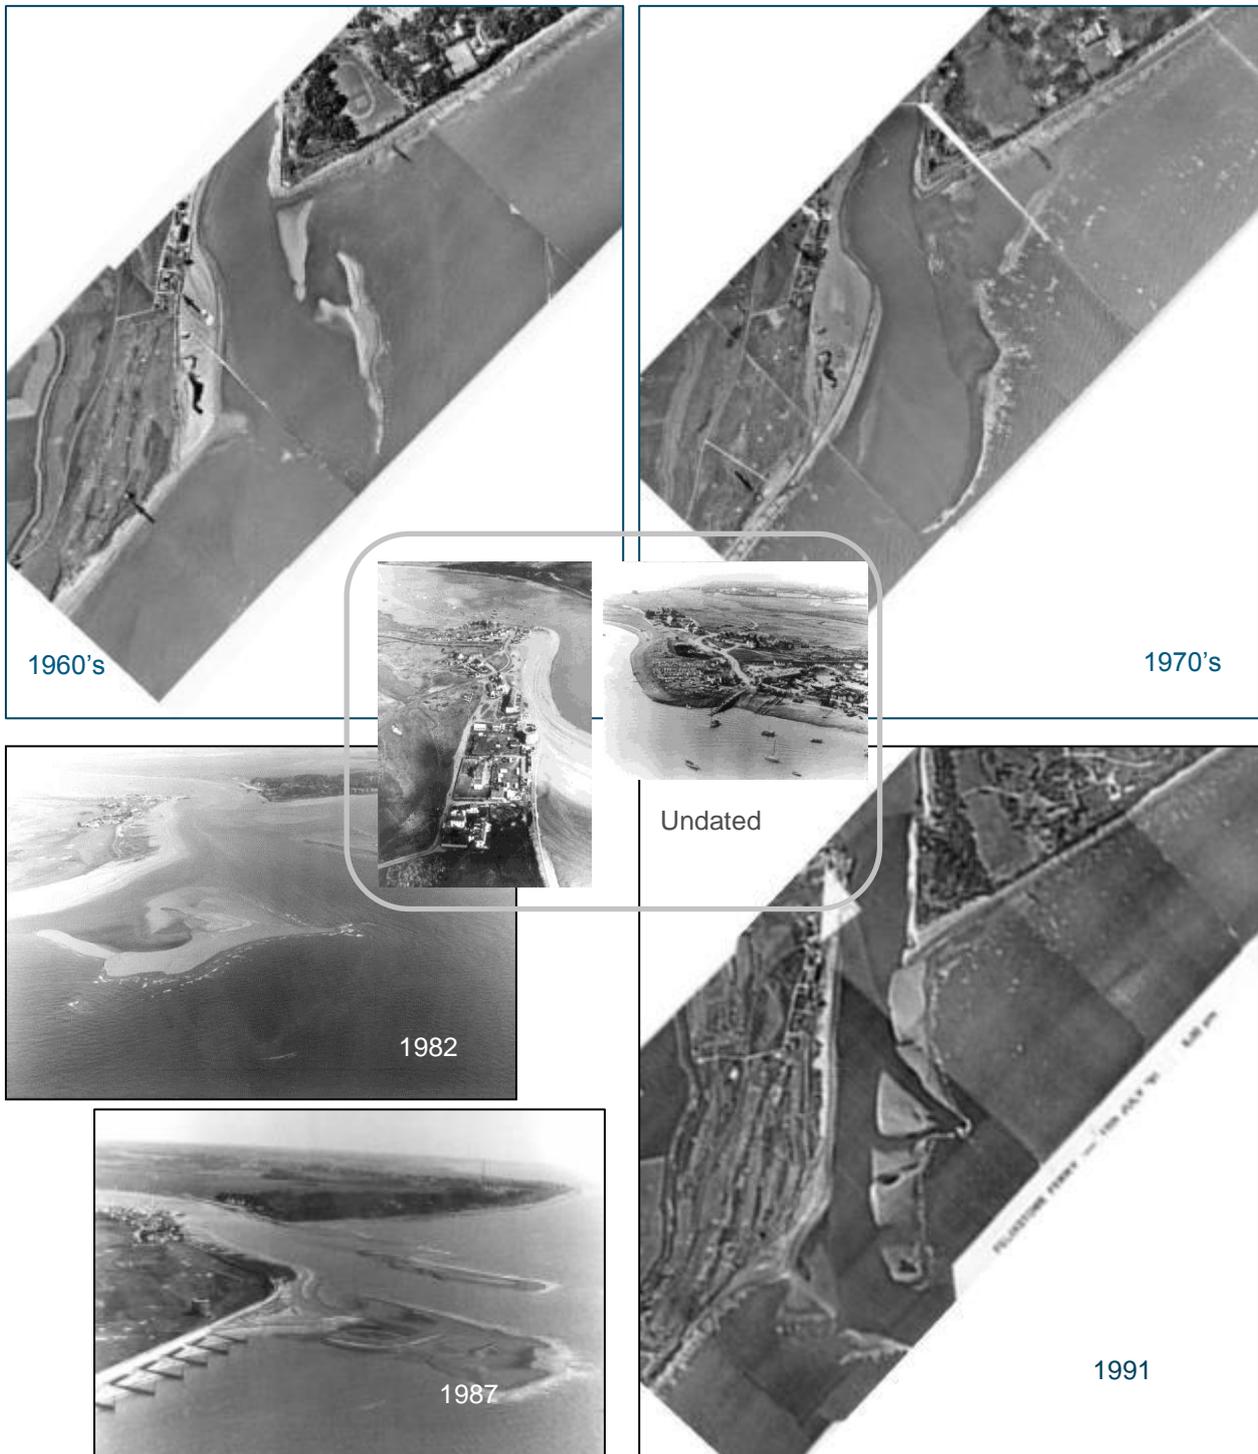
Figure 2.6. Reworking of the outer estuary between 1960s and 1991.

During this period, particularly over the 1960's and 70's, there is an indication that sediment was moved into the estuary on the western side, although being resisted by the ebb flow. Certainly, as shown in the undated inset photographs in Figure 2.6, there was significant growth around the north end of the estuary

Although rather indistinct, there is seen to be some degree of a beach, particularly in the 1960's image (Figure 2.6), in front of the sheet piled wall south of Bawdsey Quay. This is highlighted in the scanned photograph, taken in 1988, following the construction of the Tripod Terminal Groyne on the western side of the mouth. This, again, highlights the sensitivity of this frontage in relation to the main shape of the outer (and inner) estuary channel.

In terms of the Bawdsey manor frontage, again rather indistinctly shown on the images in Figure 2.6, there is some increase in the western end of the beach between 1960's and 1970's. However, the groynes further to the north are exposed.

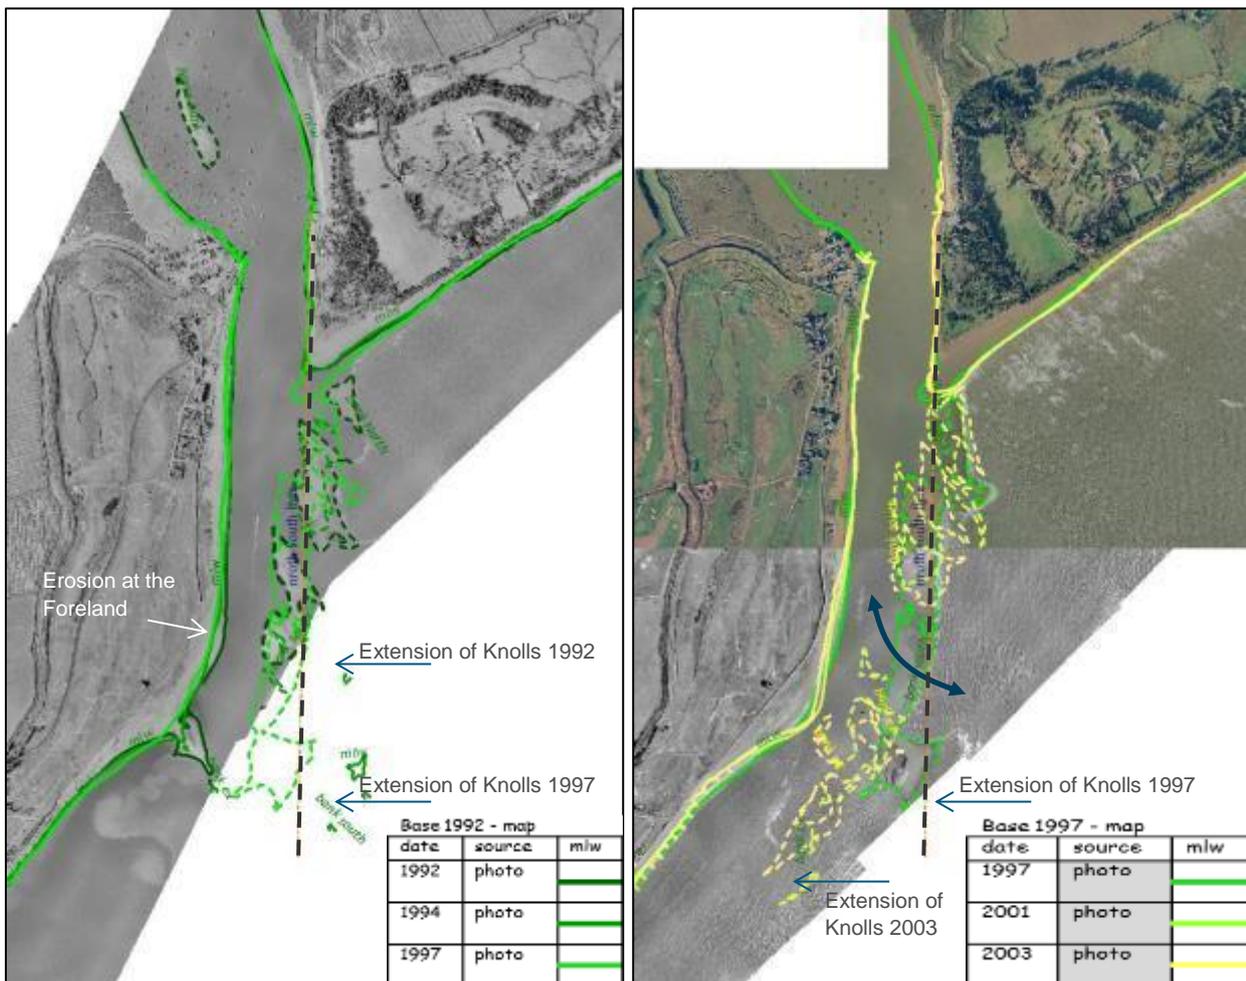
Figure 2.8 Comparison of mlw 1992 to 2003

Initially in 1992 the northern section of the Knolls (the up-drift shoals) is relatively in line with the reference line. The length of the banks stop short of the southern corner of the western shoreline (*State 1, 1992*). As this develops, the banks extend further south, over lapping the southern foreland (1997 and 2003). As the banks at the southerner push west, there is distinct erosion at the apex of the foreland (*State 2*).

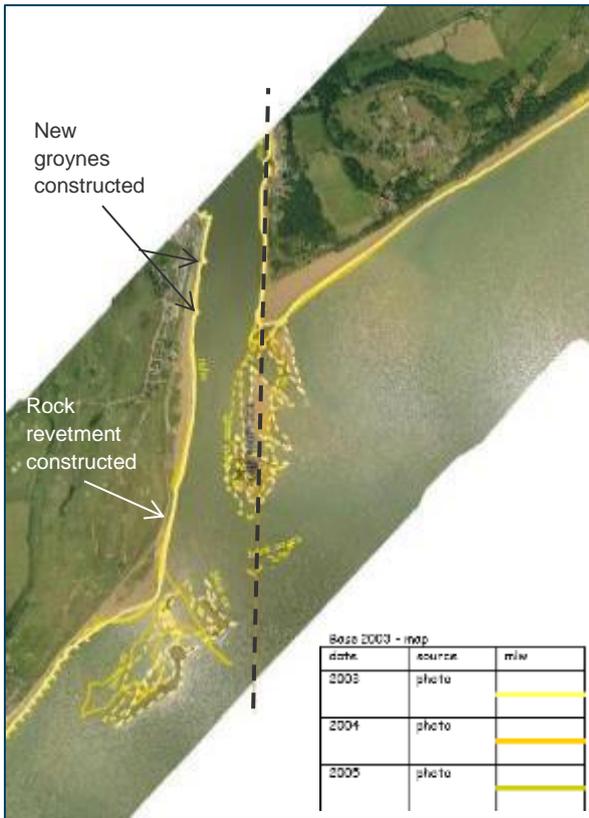
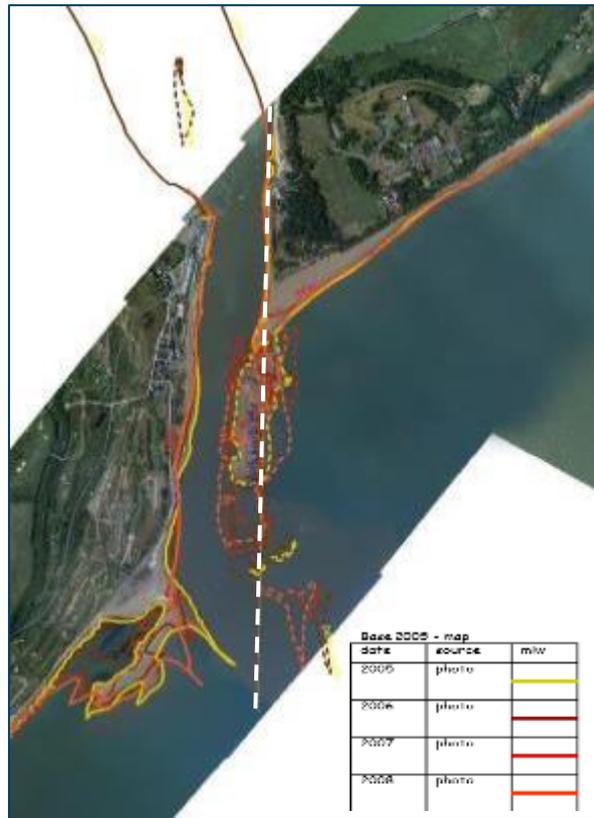
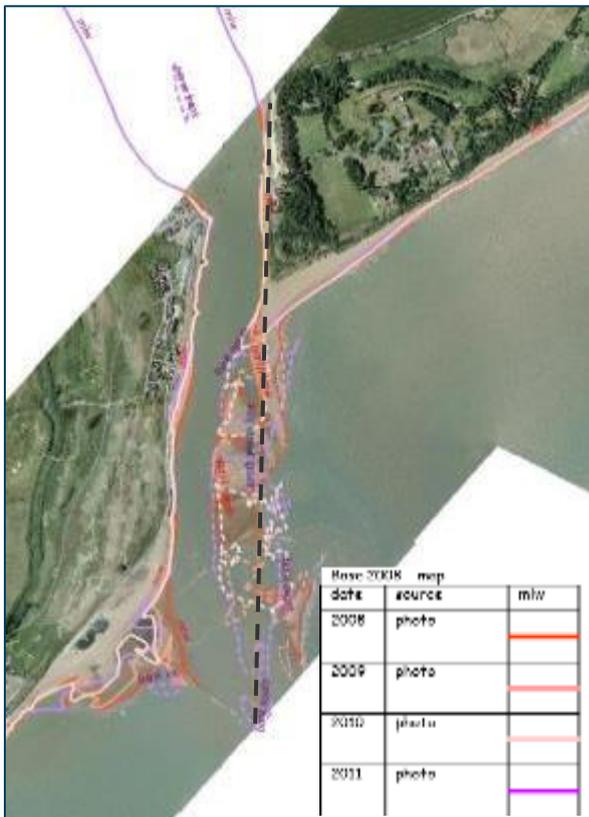
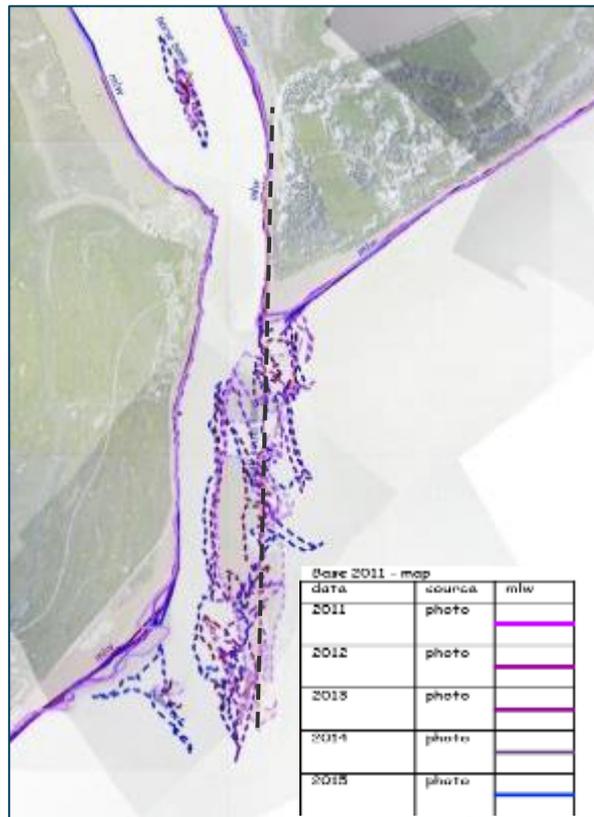
Figure 2.10 Comparison of mlw 1992 to 2003

Over the period 2003 to 2005 the Knoll banks have very definitely separated into the up drift and down drift shoals. There is a general setting back of the down drift shoal against the shoreline. As part of this process, the groyne along the southern shoreline become increasingly exposed as the down drift shoal acts as a nearshore breakwater pulling sediment in to its lee. This is clearly seen in the consistent orientation of the beach within the groyne bays.

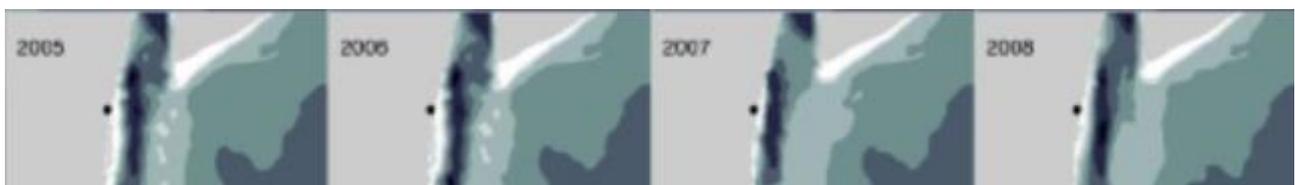
Figure 2.11. Variation across the mouth of the estuary between 2005 and 2008.

As the outer estuary starts to move from State 1 towards the more extended bank shape of State 2, between 2008 and 2011, it may be seen that the northern inner face of the up drift shoal shows an even stronger flow setting against the western shoreline north of the rock revetment. This supports the concept that this is an ebb flow symptom. There is a suggestion that that exposure along the Bawdsey Quay sheet piles may have become more severe from this time till present. This indicates a significant link between the flow pattern within the overall system and erosion of the beach in front of the piles.

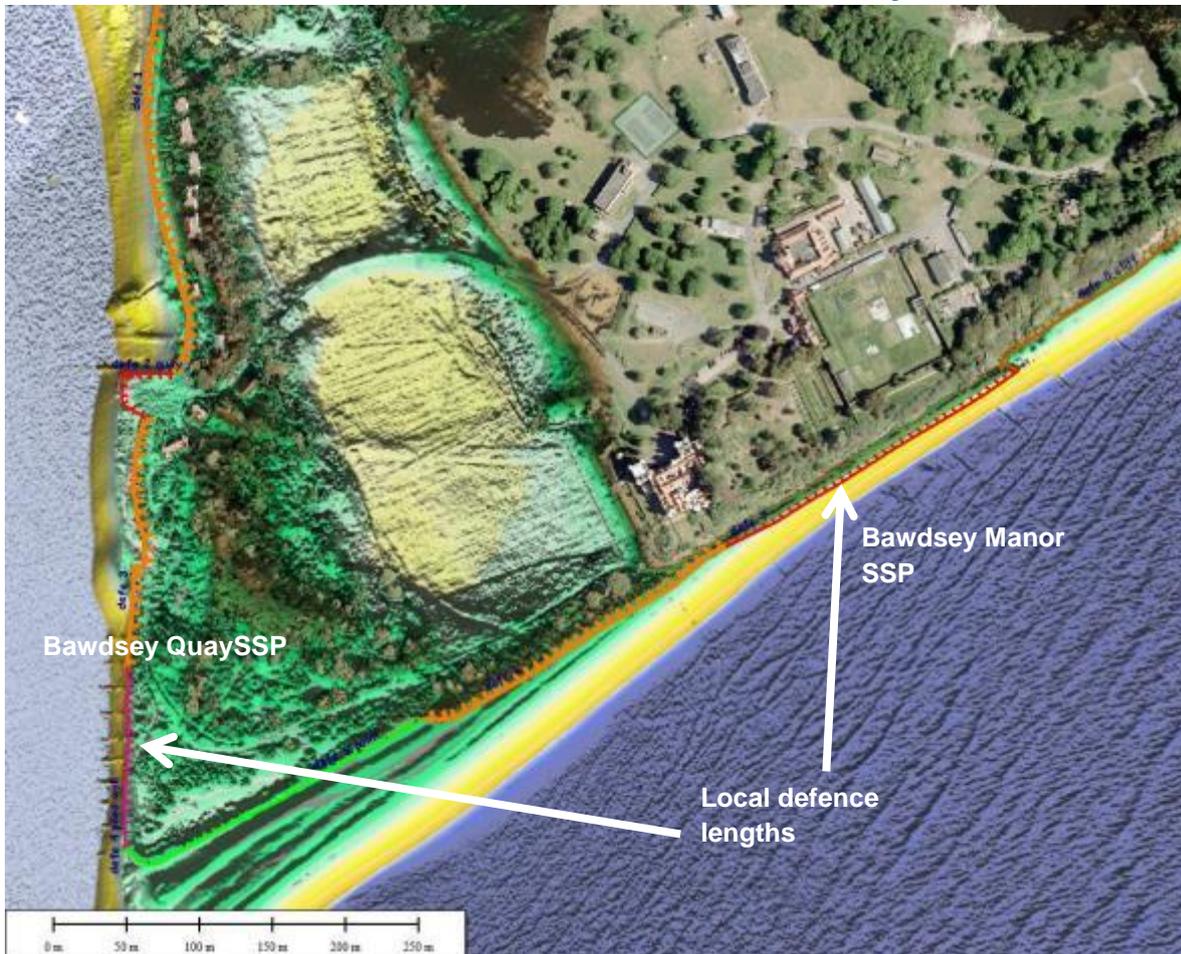
Figure 3.1. Local defences

Both sections comprise steel sheet piles fronted by dilapidated groynes. A recent inspection (2016) highlighted significant issues with respect to their condition.

In the case of the Bawdsey Manor wall, there is concern over a reduction of beach level resulting in instability, although it has been assessed that this stability issue is not at present critical. However the wall suffers from substantial overtopping and there are areas where holes developing in the sheet piles have resulted in local wash out. Local damage has occurred at the northern end of the wall and this has been supported by rip rap armour (Plate 3.1).

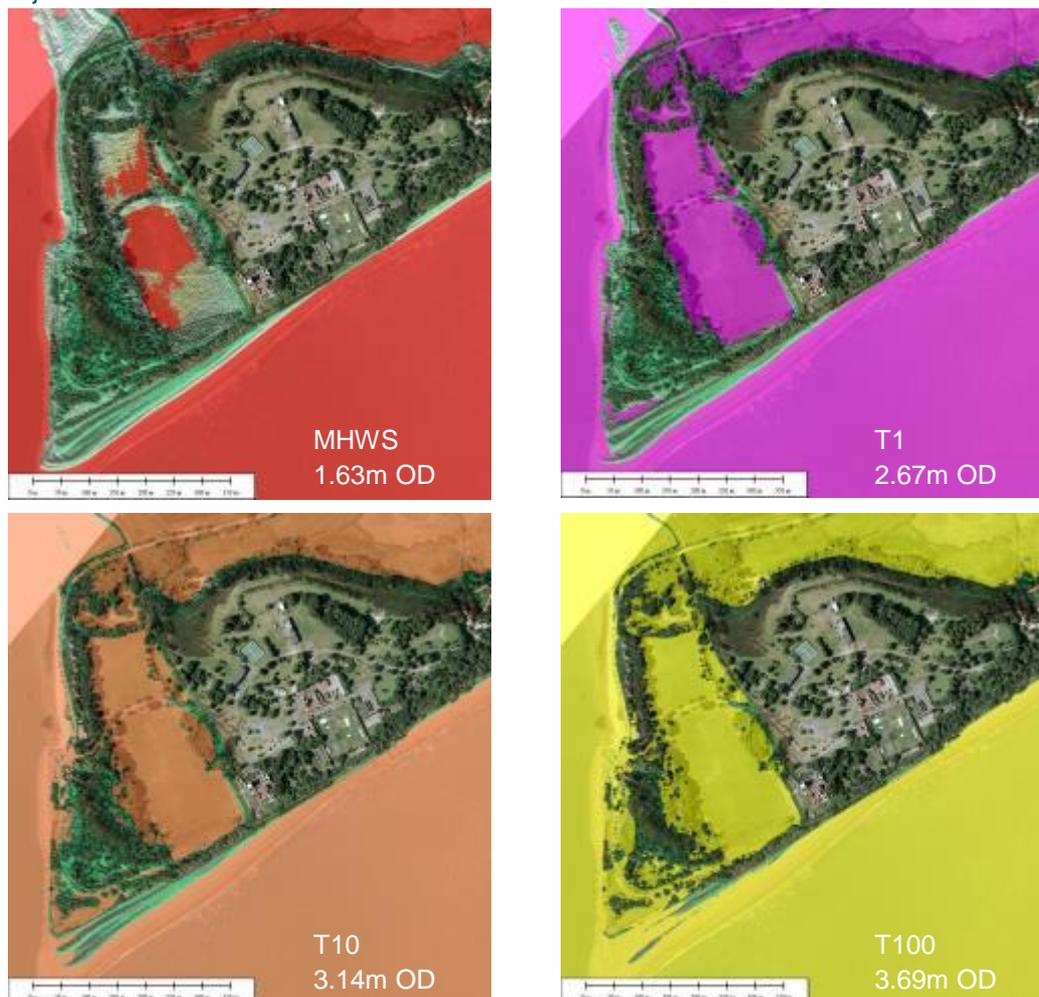
Figure 3.2. Flood risk - projection of still water levels.

It may be seen from the plots that under normal tidal conditions, while the low lying area to the rear of Bawdsey Quay is below MHWS, there is a substantial width of higher ground immediately to the rear of the defence. It is only as the 1:10 year level (T10) is reached that potential flood routes start to emerge through this basic topography. Even then it is principally the Quay itself and the main entrance to the Manor that possibly opens a path through to the wider area.

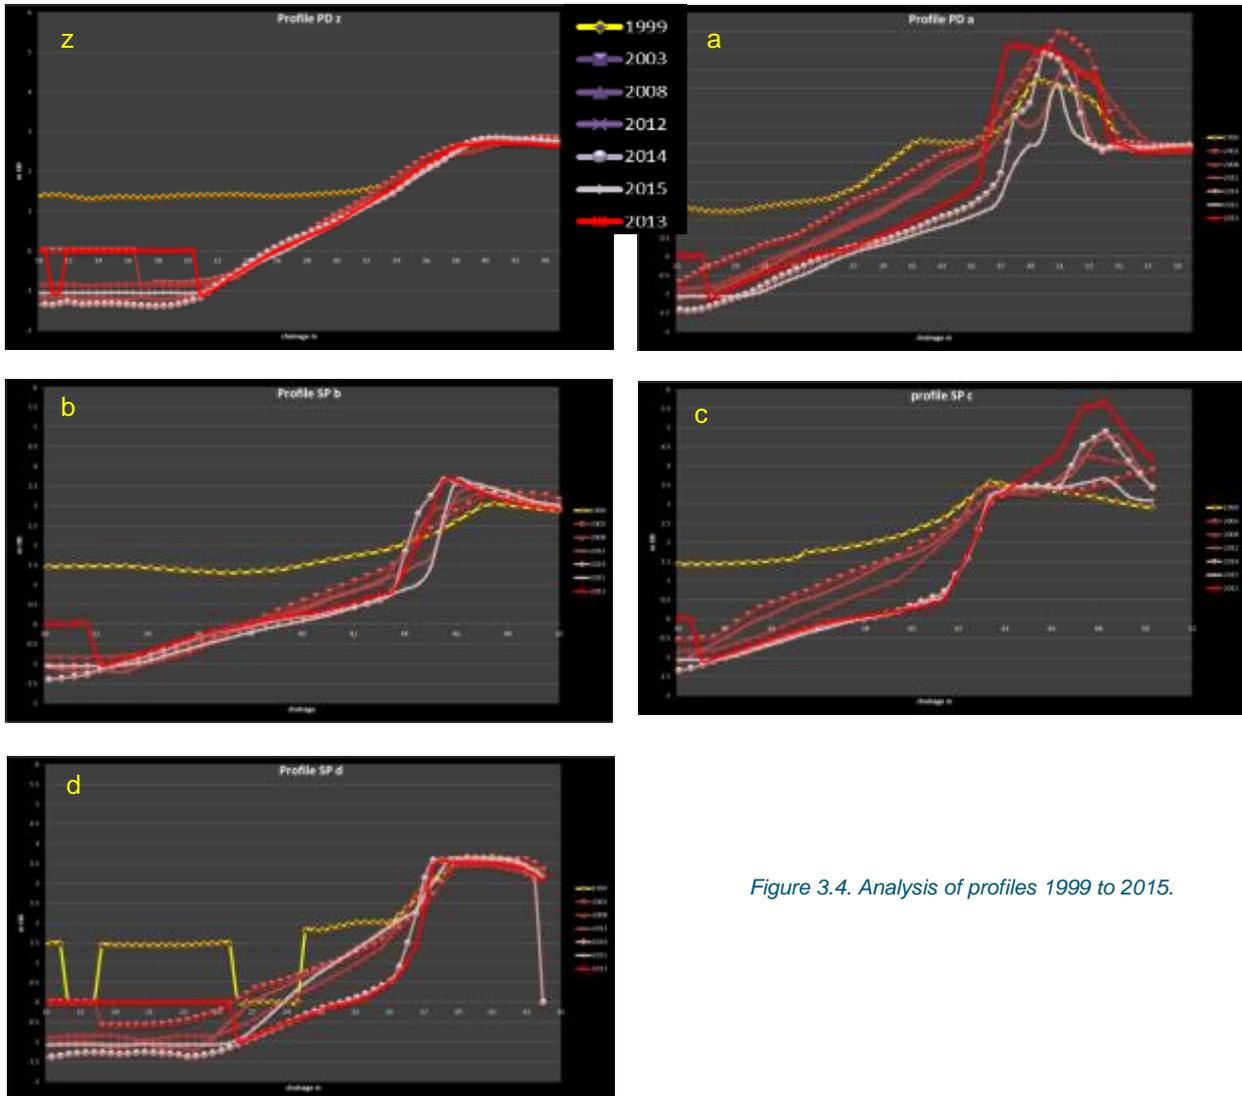
Figure 3.4. Analysis of profiles 1999 to 2015.

At the northern end of the site the profile (z) shows virtually no change, with a typical crest width of around 15m. Moving further south to profile PDa the profiles tend to lie within two groups, through to around 2012 and then a lower set of lines through to 2015. The profile line is taken at a point where there is clearly a different process occurring suggesting a transition between high and low flow pressure. A simple analysis of the approximate high water taken from the air photos shows a similar pattern with the transition point remaining relatively stable through to 2006. This interface then moves north through to 2015. This seems to match well the observed change in the banks of the outer estuary with the suggested change in flow pattern highlighted earlier.

Subsequent profiles (SP b, c and d) all show largely similar results. It should be noted however that on profile SP d, there has been significant recovery over 2015, presumably as the northern swash channel has tended to open.

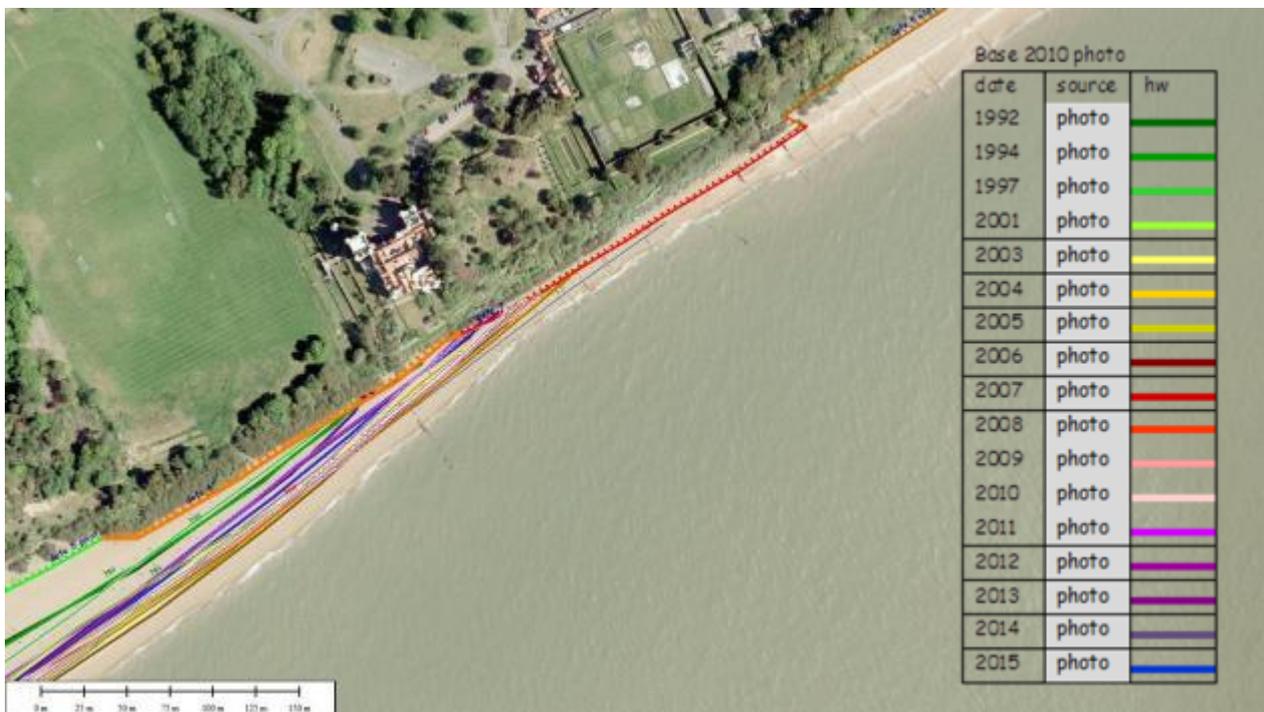
Figure 3.5, analysis of high water intersects.

The spread of intersects obviously relates to the width of the beach to the west. The overall range of intersect is around 150m demonstrating that, while the area of pressure is quite consistent, the actual length of vulnerable wall can vary. Considering the general colour groups set out in the key, this is, to a

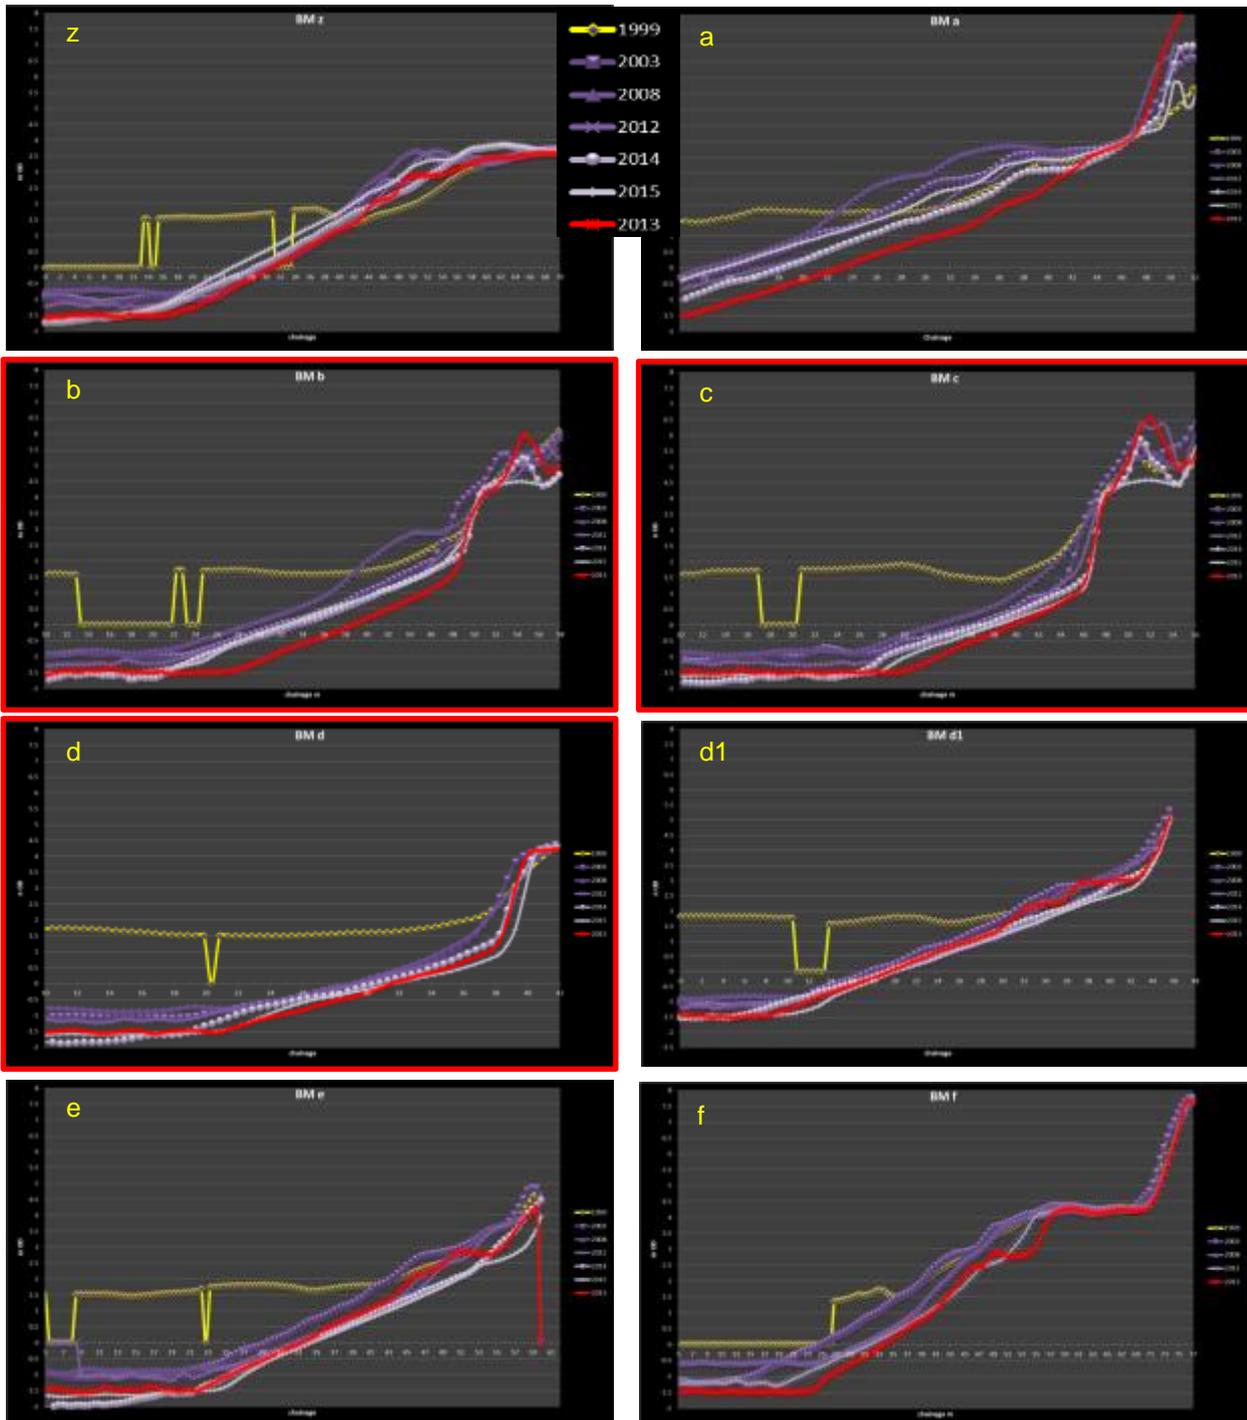
Figure 3.7. Variation in beach levels. Profiles framed in red are directly in front of the critical section of defence.

All survey results for profile BMz (west of the defence) are above the baseline survey (1999). Typically beach levels for 2003 and 2008 are most advanced, levels decrease to 2013 (shown in red) and increase slightly through 2014 and 2015. Profile BMa, just north of the defence shows a similar pattern to that of BMz.

Overall there seems to have been continuing loss over 2014 and 2015 over the northern section of the frontage with slight corresponding gains along the more western profiles. While this is not in itself evidence of southerly drift, it does support the basic concept. The Lidar from 2013 would have been prior to the major extreme water events of November and December in 2013. It is notable, therefore, that generally the 2014 profile, particularly over the western section of the defence do not show greater loss.

In terms of the actual defence section, while there has typically been erosion since 1999, there is little evidence of any rapid recent trend of erosion. This is considered further in the second analysis based on dip records in front of the sheet pile wall, taken every week over the period 2013 through to 2016.

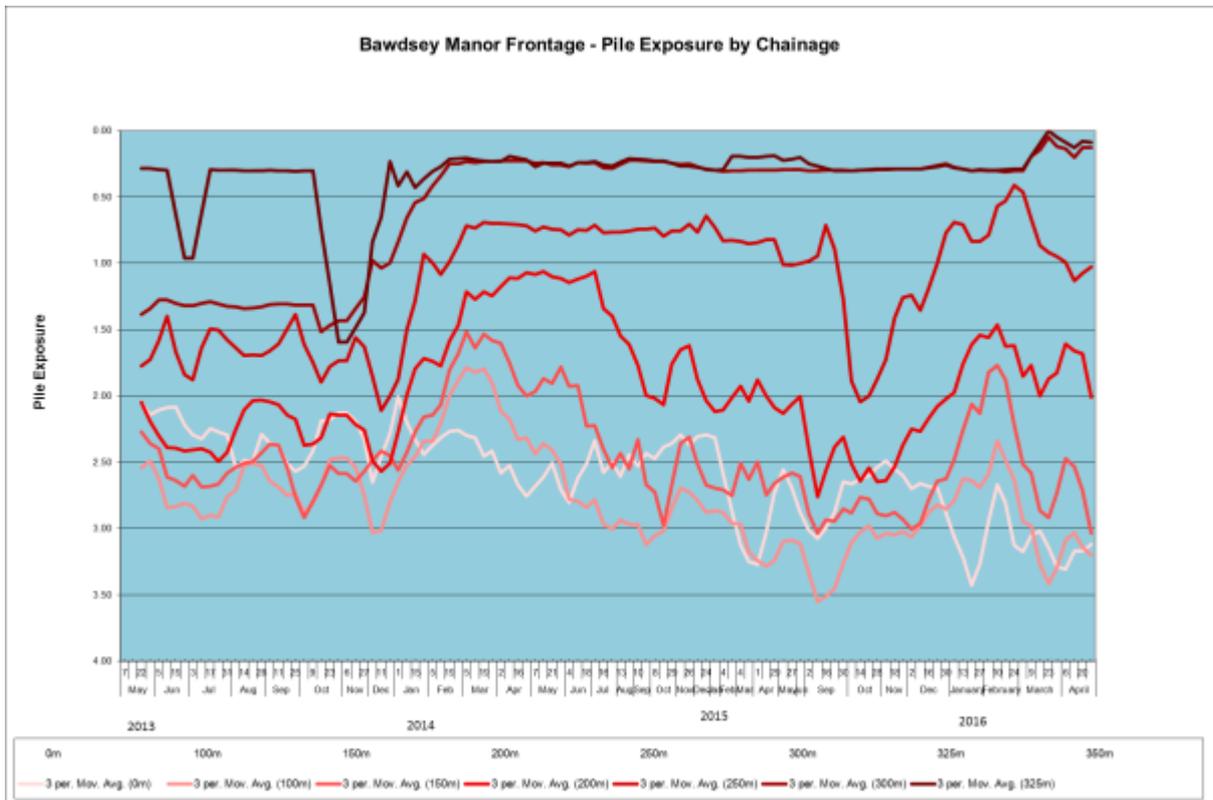
Figure 3.9. weekly dip records of pile exposure averaged over 3 record points.

From chainage 0 to chainage 150, there has been a relatively consistent trend of beach loss, while at chainages 200 to 300 show little net change over the period. This has to be placed in the longer term perspective discussed above.

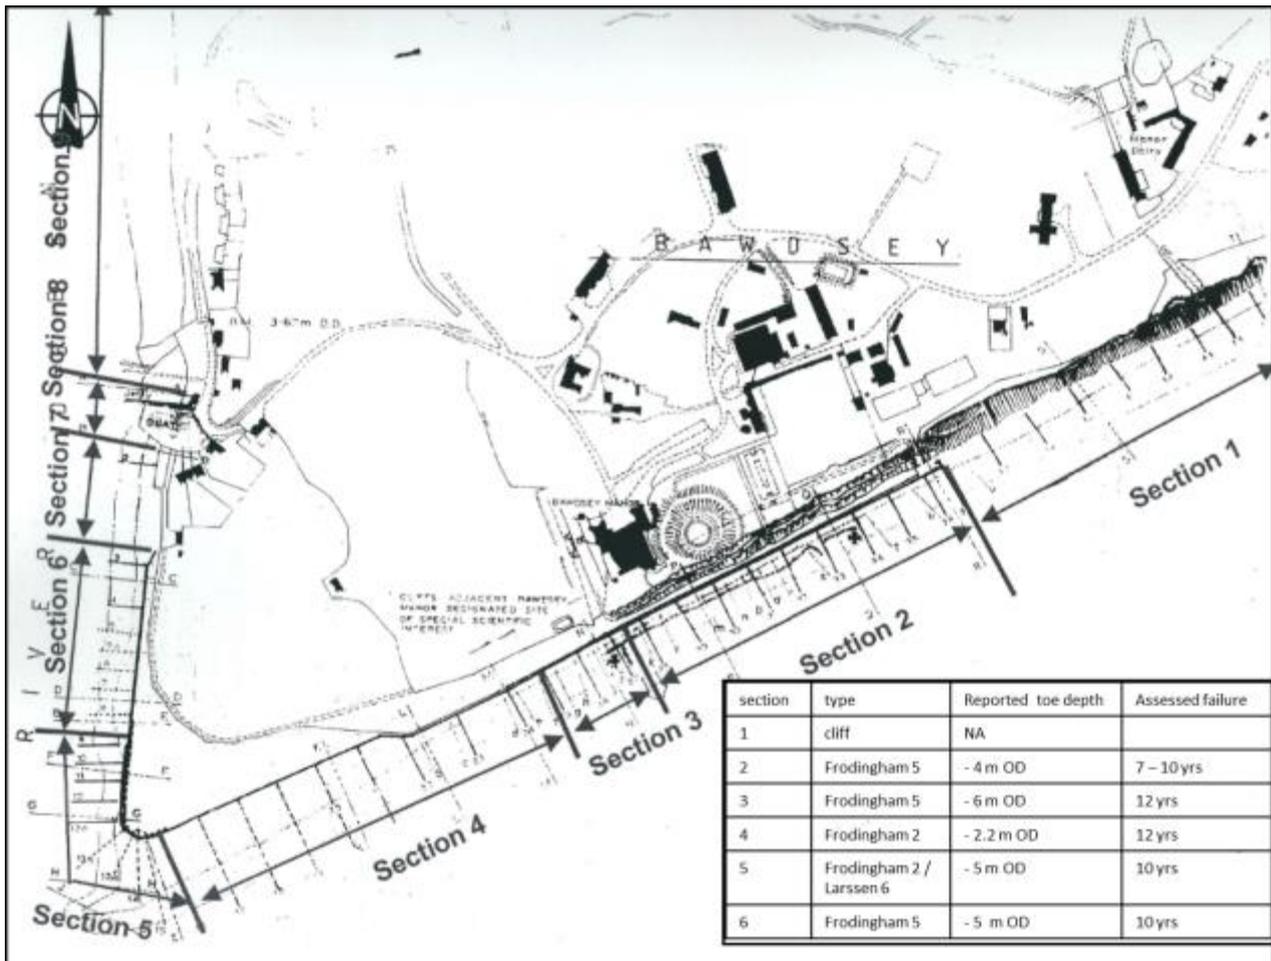
Figure 4.2. Definition of defence sections, with assessed details (2003)

In review, in general, the concerns and issues raised by the report and the typical response of the estuary and frontages still seem valid. It should, however, be noted that the Quay has been significantly improved and the timescale of associated with failure of this feature and other defences are possibly extended. Figure 4.2 shows the defence sections referred to in the previous report. These are used as a reference in the following discussion. The original assessment of pile depth and residual life is included in the Figure.

A recent inspection of the frontage, to the west of the Manor, highlighted a section of piles (referred to as Section 4 in the previous report) where, where visible, the top of the piles are severely degraded. This tends to be further towards the Point. Closer to the Manor, and directly across the low lying land, the visible section of the piles show some damage but remain well buried. This confirms the previous

assessment, within the 2003 report, recording that the section most severely damaged are Frodingham 2 piles and the shorter section of buried piles are Frodingham 5.

It was suggested in the 2003 report that both Section 3 and the more westerly Section 4 might typically have a life of 12 years. Clearly this has been exceeded and the strength of the piles have not really been put to the test. Given that in this area beach levels seem to be maintained, potentially the threat of failure comes either from the risk of Section 3 being outflanked by failure of the piles in front of the Manor or over the longer term with sea level rise.

With respect to the former issue, while there is the need to address short term issues, such as the damage to the northern end of the Bawdsey Manor Sheet Pile wall and local damage to the pile, quite probably further works would not become critical for some 5 years. Even then a staged approach might be taken to addressing the problem, as suggested in the 2003 report, a rock toe, building on this with a more substantial rock revetment in 10 to 15 years time. As such the risk to the integrity of Sections 3 and 4 are moved through towards this typical time scale.

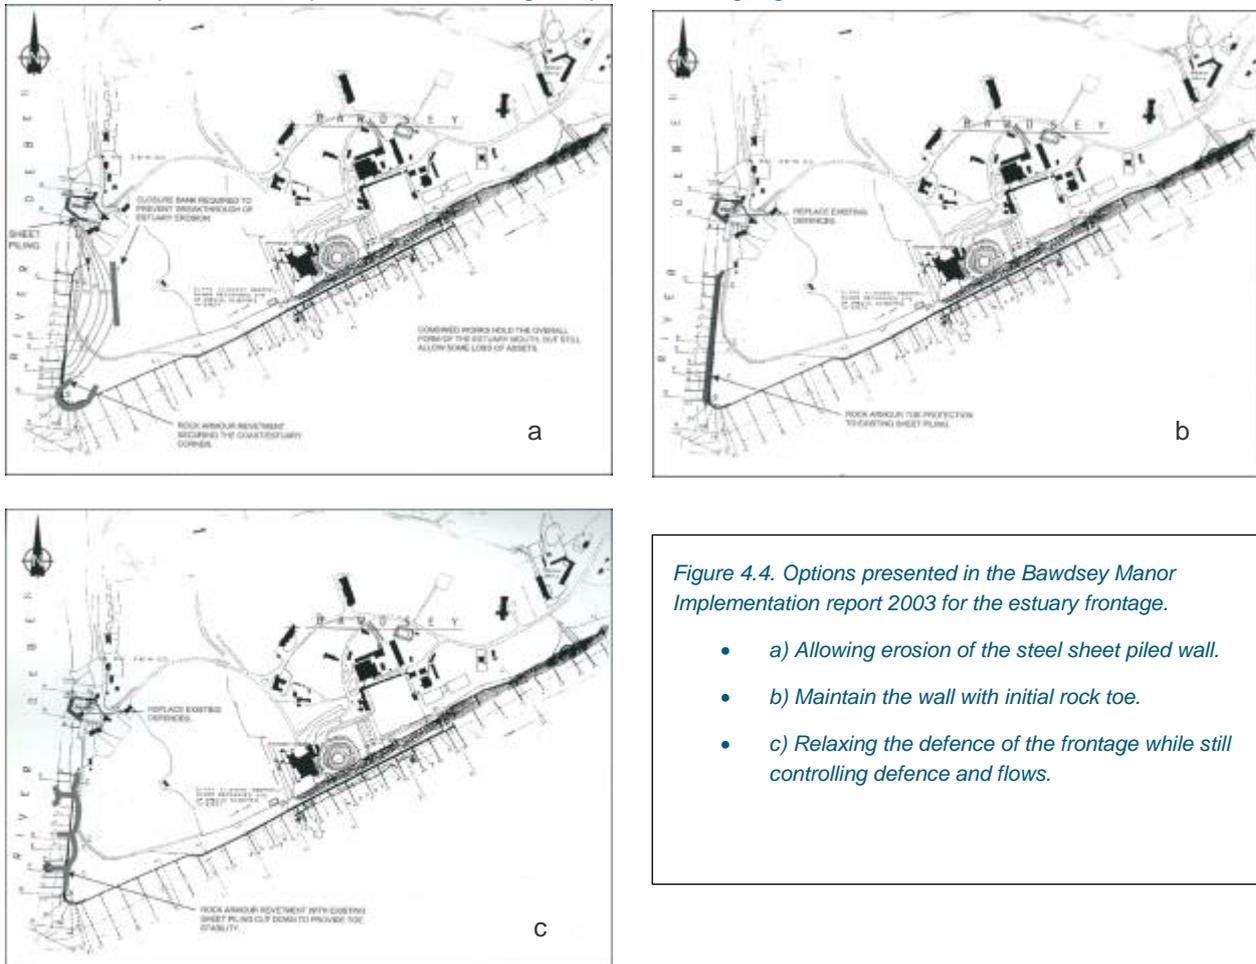
Figure 4.4. Options presented in the Bawdsey Manor Implementation report 2003 for the estuary frontage.

- Reinforcing the Quay (which has since been undertaken) while allowing erosion to occur between the Quay and the Point (Figure 4.4 a).
- Undertaking further support of the sheet piles with a rock toe as initial early works (Figure 4.4 b)

- Relaxing the defence line along the steel sheet pile section of defence down the Point (Figure 4.4c).

- a) Allowing erosion of the steel sheet piled wall.
- b) Maintain the wall with initial rock toe.
- c) Relaxing the defence of the frontage while still controlling defence and flows.
